TRANSOM WINDOWS MAIN STREET IOWA TECHNOTES

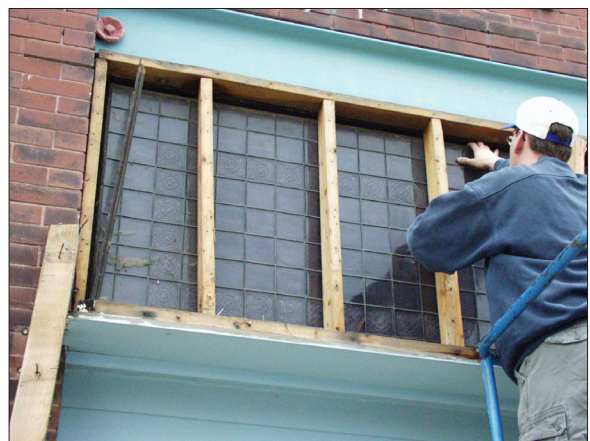
Transom window can be made of several types of glass:

- ***clear***
- ***frosted or etched***
- ***ribbed or reeded***
- ***stained***
- ***beveled***
- ***4" square tiles***

Transom window glass comes in a wide variety of shapes, colors and styles. Some glass is clear, like the display windows, and some is frosted or etched to diffuse sunshine. Ribbed or reeded glass is also frequently used in transom windows. Varieties of stained glass, beveled glass and 4" square glass tiles are commonly used in leaded windows. Leaded windows have lead or zinc comes that hold together the pieces of glass. Angled reinforcing bars are also used to prevent the windows from sagging or bowing.

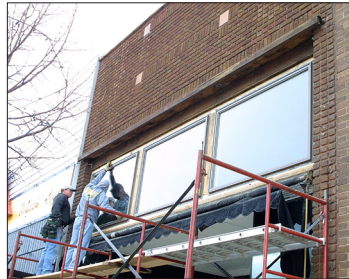
disguise mechanical, electrical and plumbing systems. By removing a section of the ceiling near the front of the building where there is little or no mechanical equipment, the transom windows and the light they provide can often be incorporated into the interior decor. The suspended ceiling can then be angled from the transoms to the lowered height.

A vertical bulkhead is another option for transition to the suspended ceiling.

By removing a section of the suspended ceiling at the front of the building, the transom windows can be incorporated into the interior decor.

The suspended ceiling can be angled from the transoms to the lowered height...

...or a vertical bulkhead can be built.
